Environmental Resource Inventory Borough of Lindenwold

**May 12, 2010
Rev. June 21, 2010**

Borough of Lindenwold, Camden County, New Jersey
Prepared by Environmental Resolutions, Inc.

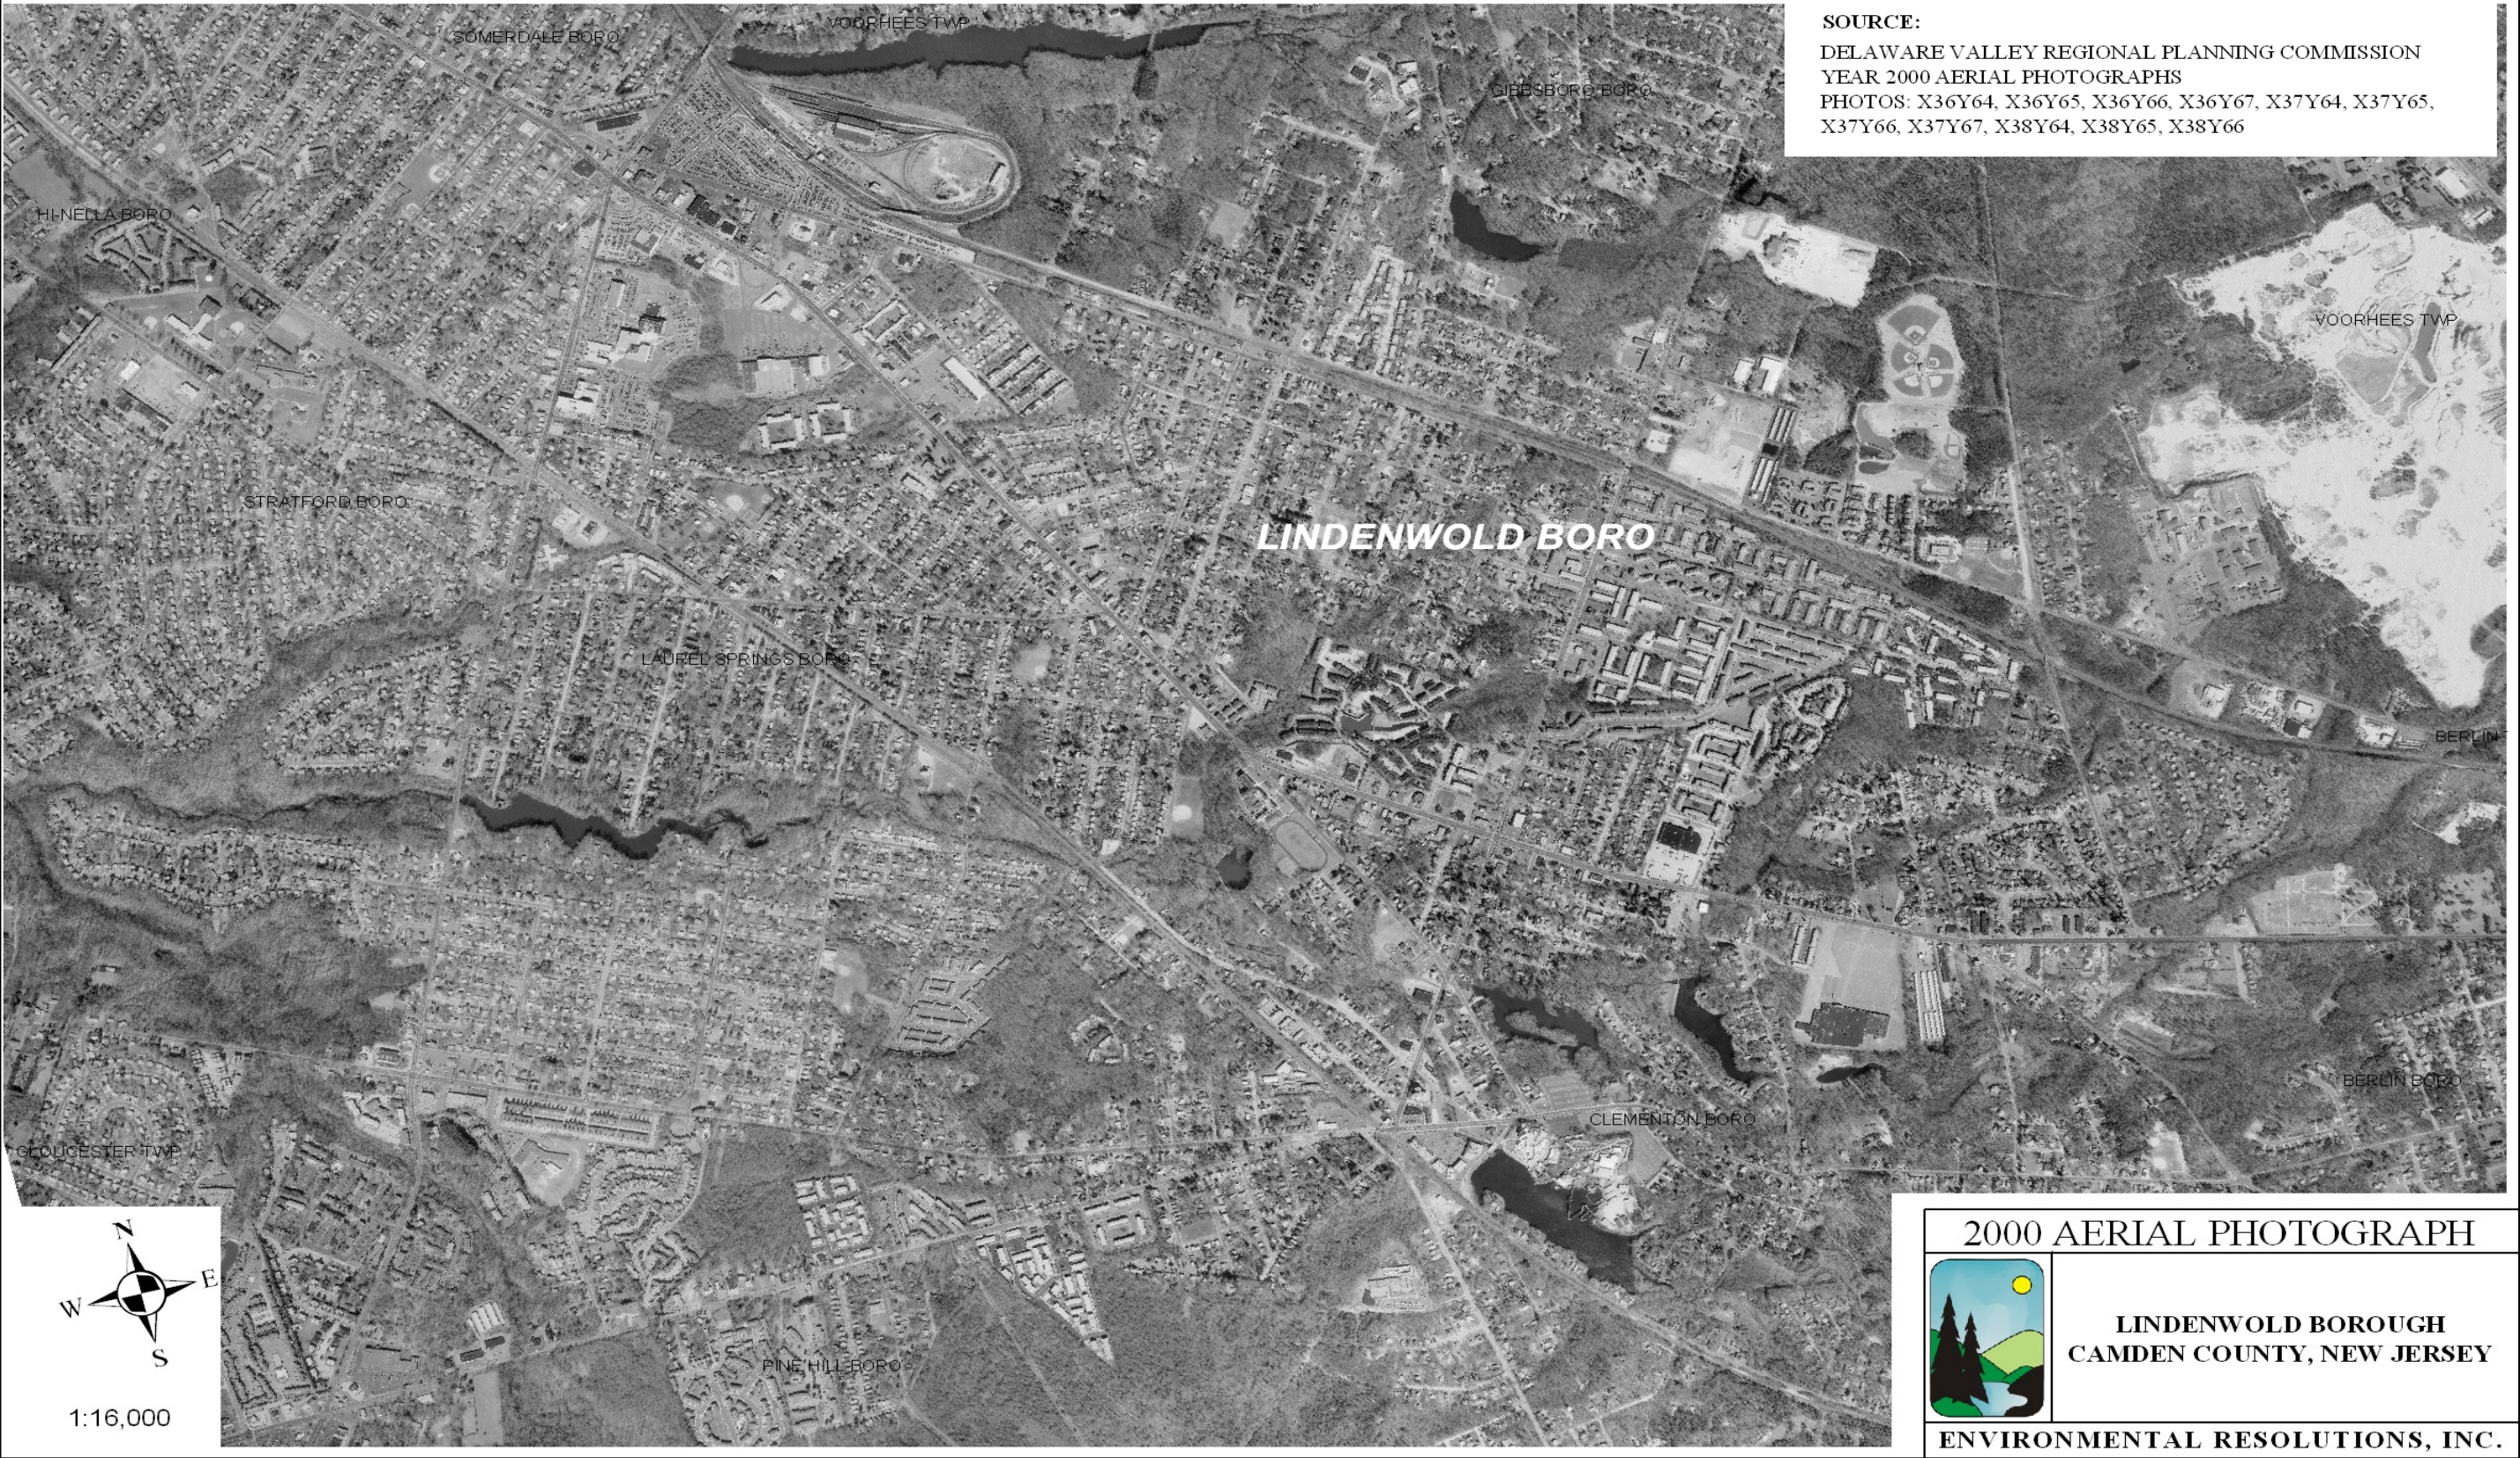
FIGURE 4 – AERIAL PHOTOGRAPH OF LINDENWOLD AND SURROUNDING COMMUNITIES

Figure 4 shows aerial photographs of Lindenwold and the surrounding communities taken in 2000. It can be seen that Lindenwold and the local areas around Lindenwold are predominantly residential communities. The multi-family buildings can be seen in the aerial as the larger buildings grouped in clusters. Large lakes and streams appear as dark areas on the aerial. The commercial development with larger parking lots can be located along the White Horse Pike (U.S. Rt. 30).

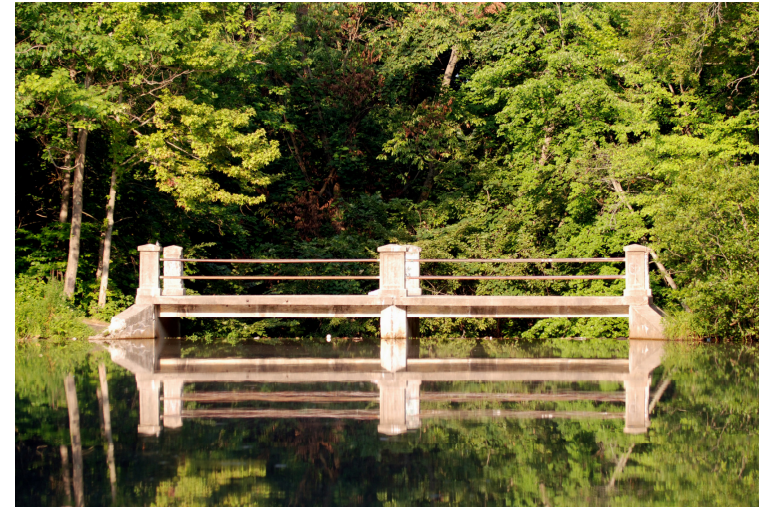
Overbrook Lake. Overbrook Lake is formed from a former marl pit that has been inactive since 1877. The lake is the result of an impoundment of the Big Timber Creek system and is currently held up by a spillway structure that was built in 1940. The lake is located behind the

Lindenwold Middle School
Photo 5, Overbrook Lake, Bodine
between the White Horse Pike (Rt. 30) and Elm Avenue.

Overbrook Lake. There are no known studies or reports for Overbrook Lake. In 2009, Environmental Resolutions, Inc. and Taylor Wiseman & Taylor conducted a dam inspection at the lake. The concrete spillway and earthen dam were found to be in fair to good condition. The spillway has signs of minor cracking, deterioration, and efflorescence at the pier, abutment walls, and flared retaining walls.

A report was developed from the inspection results. In order to ensure and prolong the life of the dam the following recommendations were suggested in the report:

- Repair or replace the low level sluice gate to allow for proper operation. This will allow the lowering of the lake and a more in-depth inspection of the spillway.
- Remove the trees and brush from within the limits of the dam on both upstream and downstream slopes. The slopes should be stabilized with stabilization matting, topsoil, and seed.
- An Operations and Maintenance Manual (O & M) should be prepared as per current Dam Safety requirements.

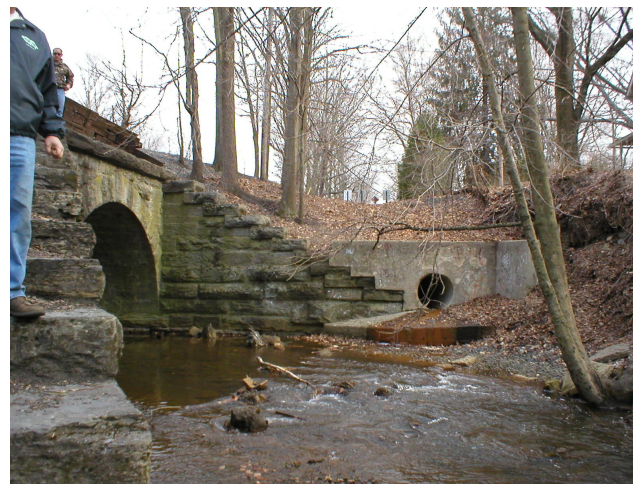
The “Indian Steps” – The “Indian Steps” are located at the crossing of the tributary of the Big Timber Creek between Overbrook Lake and Laurel Lake as it travels under East Atlantic Avenue and the New Jersey transit rail line in the vicinity of the intersection of Wallace Avenue and West Atlantic Avenue. The name of the “Indian Steps” may have originated during the early 1900s when the Laurel Mills School building was being used as a movie prop by the Lubin Moving Picture Company of Philadelphia. Some scenes in the movie were shot at Laurel Lake where an Indian village had been erected. After that, the area has always been known as the “Indian Steps.”

Photo 6, “Indian Steps” on North Branch of Big Timber Creek, Becica

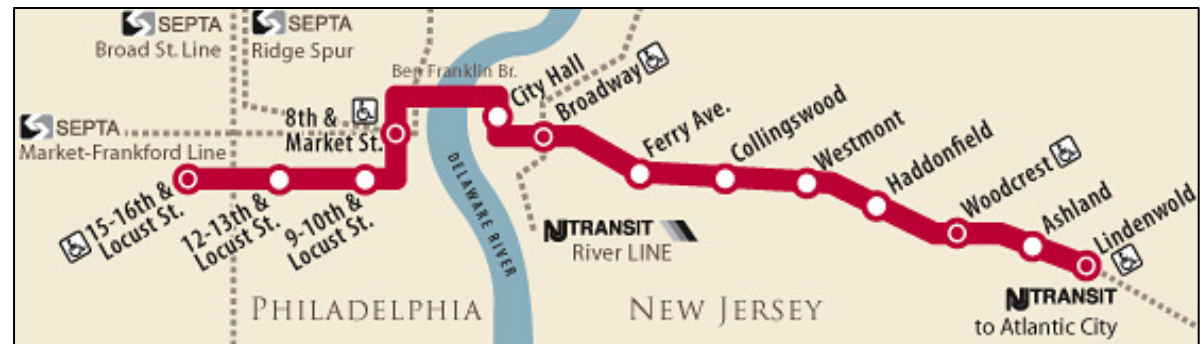
PATCO began service with eight stations in Camden County, New Jersey and four in Philadelphia, Pennsylvania. Six of the New Jersey stations provided Park and Ride service. In February of 1969, service was extended to Lindenwold, NJ. The first trip from Lindenwold, NJ to Center City in Philadelphia took place on February 15th, 1969. The Lindenwold station connects to not only the PATCO line, but also to the NJ Transit Atlantic City Rail lines. The parking lot accommodates 3,300 vehicles and many additional riders take the NJ Transit bus to get to the Lindenwold station.

Photo 8. Overall Route Map for PATCO [7]

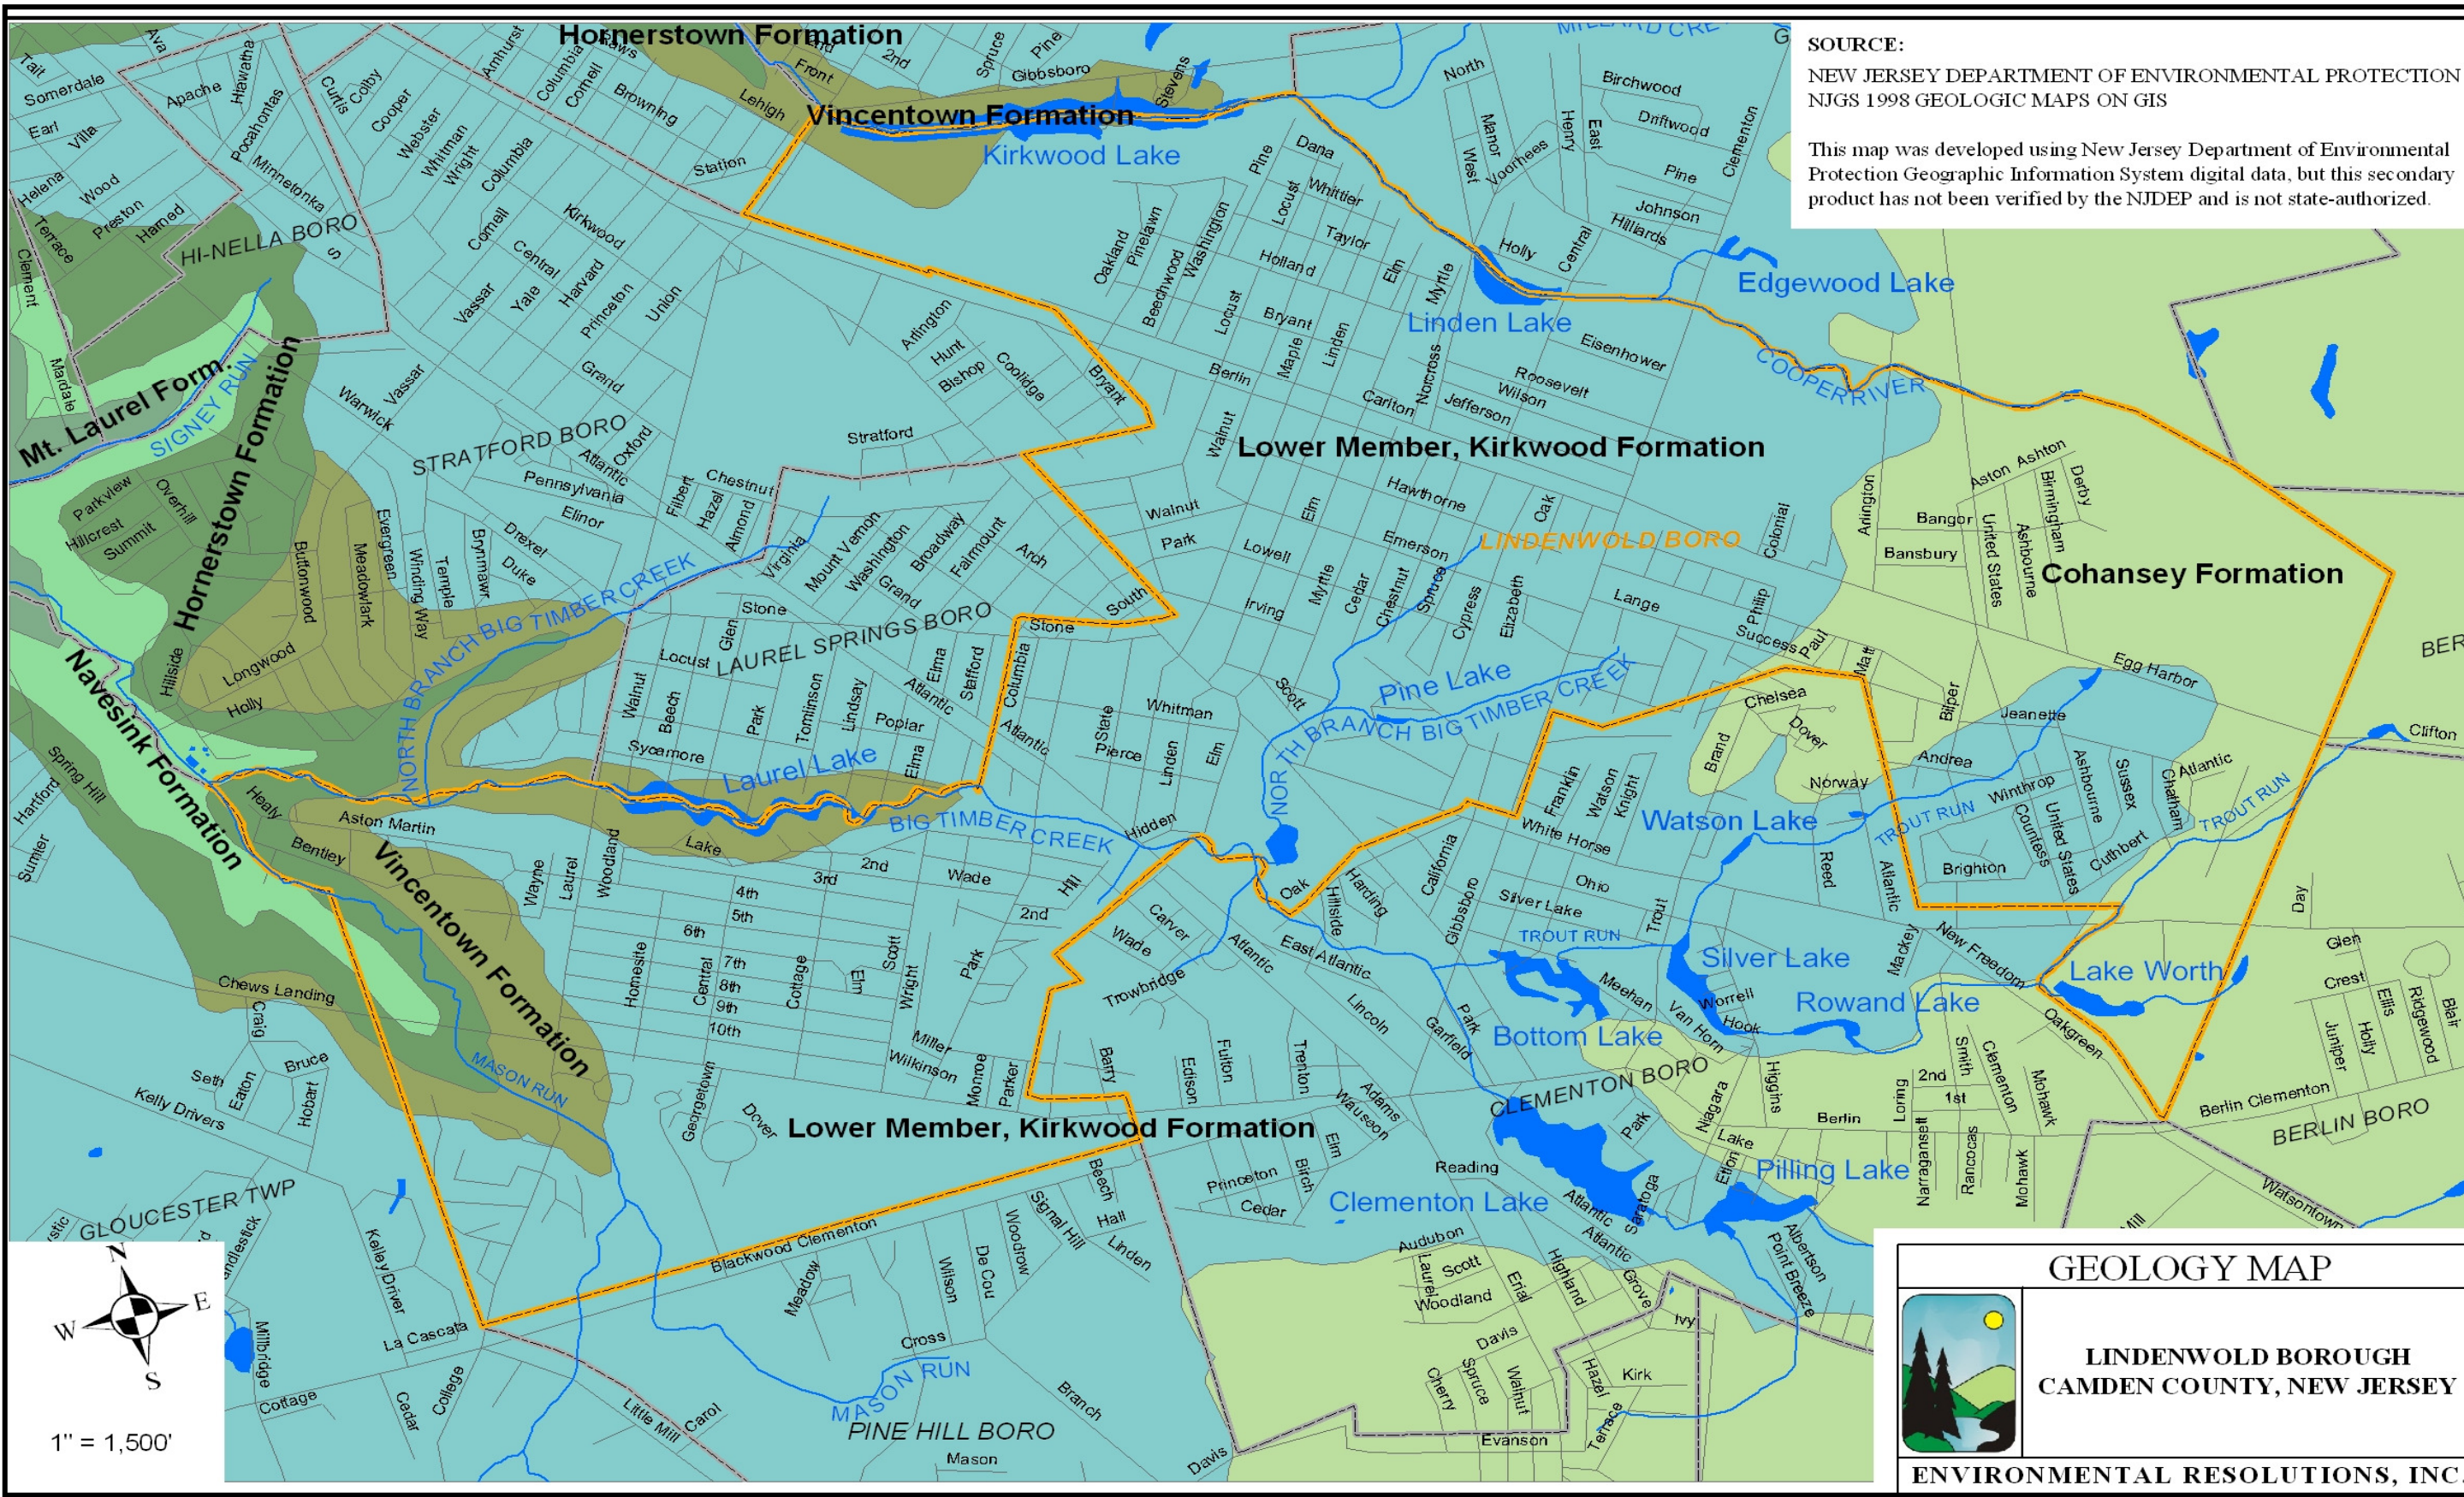
FIGURE 7 - GEOLOGY OF SOILS IN THE BOROUGH OF LINDENWOLD

The United States Soil Conservation Service lists fourteen (14) different soils found in Lindenwold. These fourteen (14) soils predominately fall into three (3) main categories of soil: sands, sandy loams, and urban soils. The soil types are categorized below.

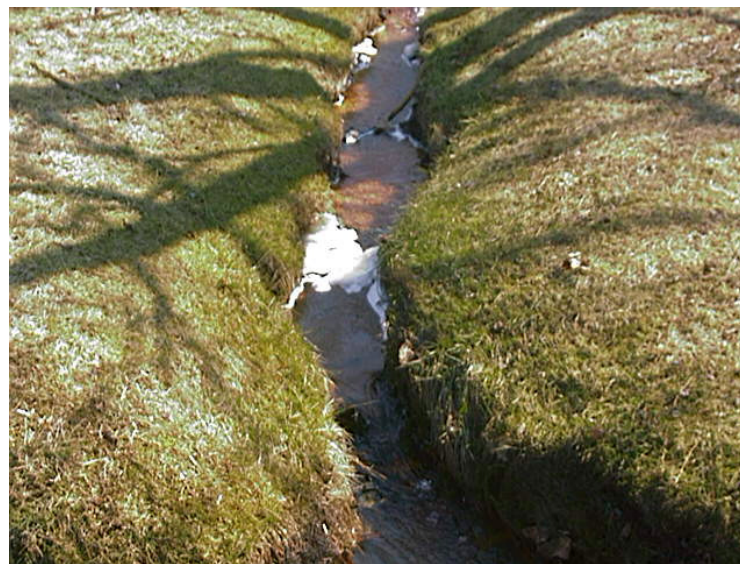
Photo 34, Ditch at Coachman Manor Apartments where lake previously existed as headwater to Big Timber Creek, Becica

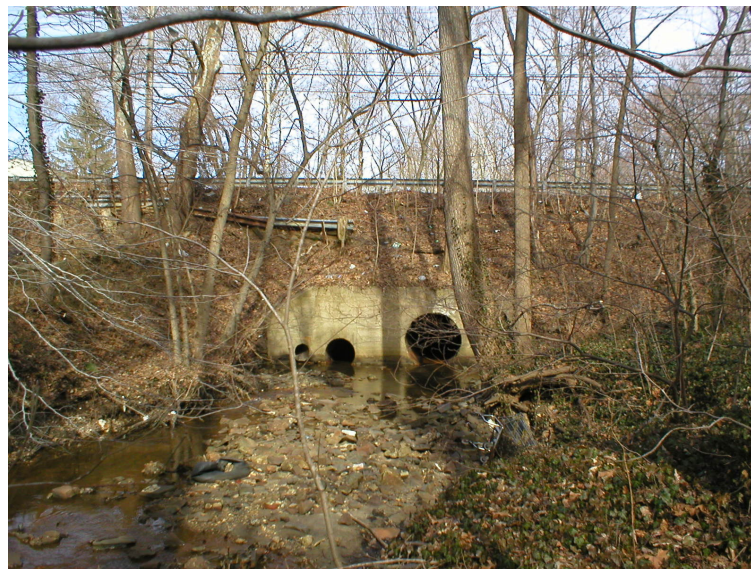
show signs of erosion, embankment failure,

Photo 35, Storm Pipes Discharging from Under White Horse Pike, Becica

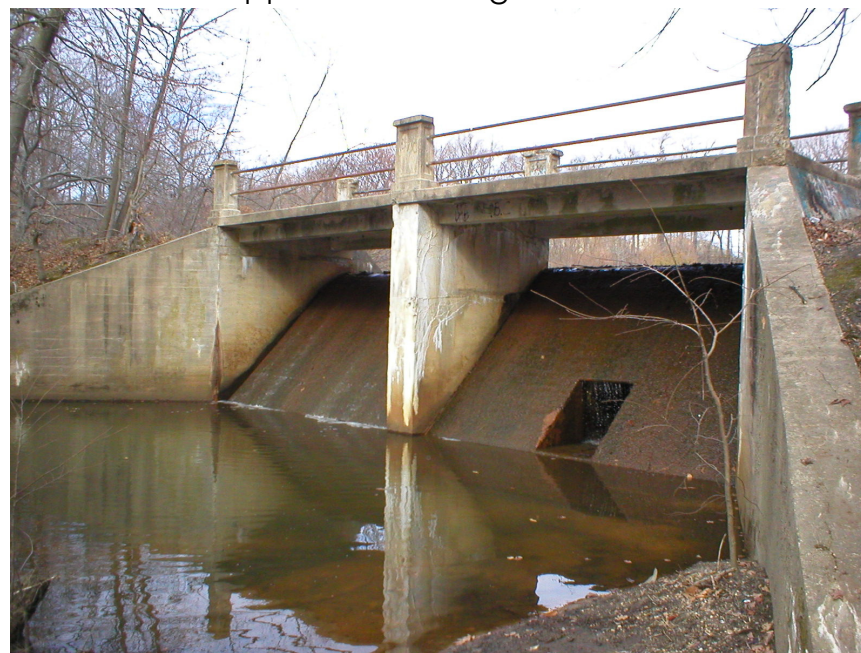
Overbrook Lake is created by a dam structure built during the Great Depression. The structure appears to be in good condition but needs regular inspection and maintenance due to its age. The dam was inspected by a structural engineer for the Lindenwold Board of

Education in Jan. Photo 36, Dam Structure at Overbrook Lake, Becica 2009 and a technical report was submitted to the State of New Jersey Dam Safety creating a five year plan.

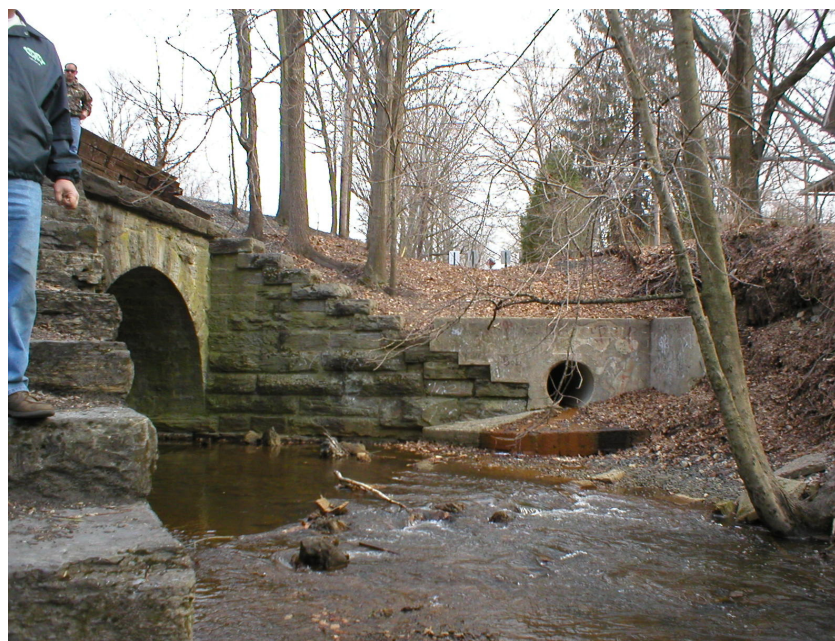
Berlin Borough. The stream widens and travels through a wetland area before crossing under East Atlantic Avenue and the railroad line at a structure known locally as the Indian steps. After the stream travels under the rail line, it must turn ninety degrees and a storm pipe also discharges flow into the stream from Atlantic Avenue to the east. The opposite embankment is severely eroded.

Photo 29, "Indian Steps" on North Branch of Big Timber Creek, Becica

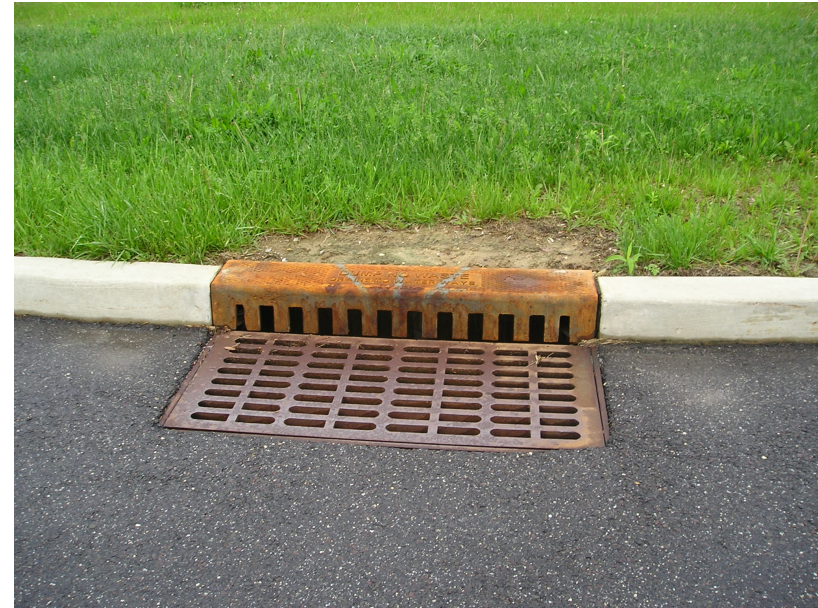
Photo 37, Storm Inlet in Conformance with Attachment C of Stormwater Regulations, Becica

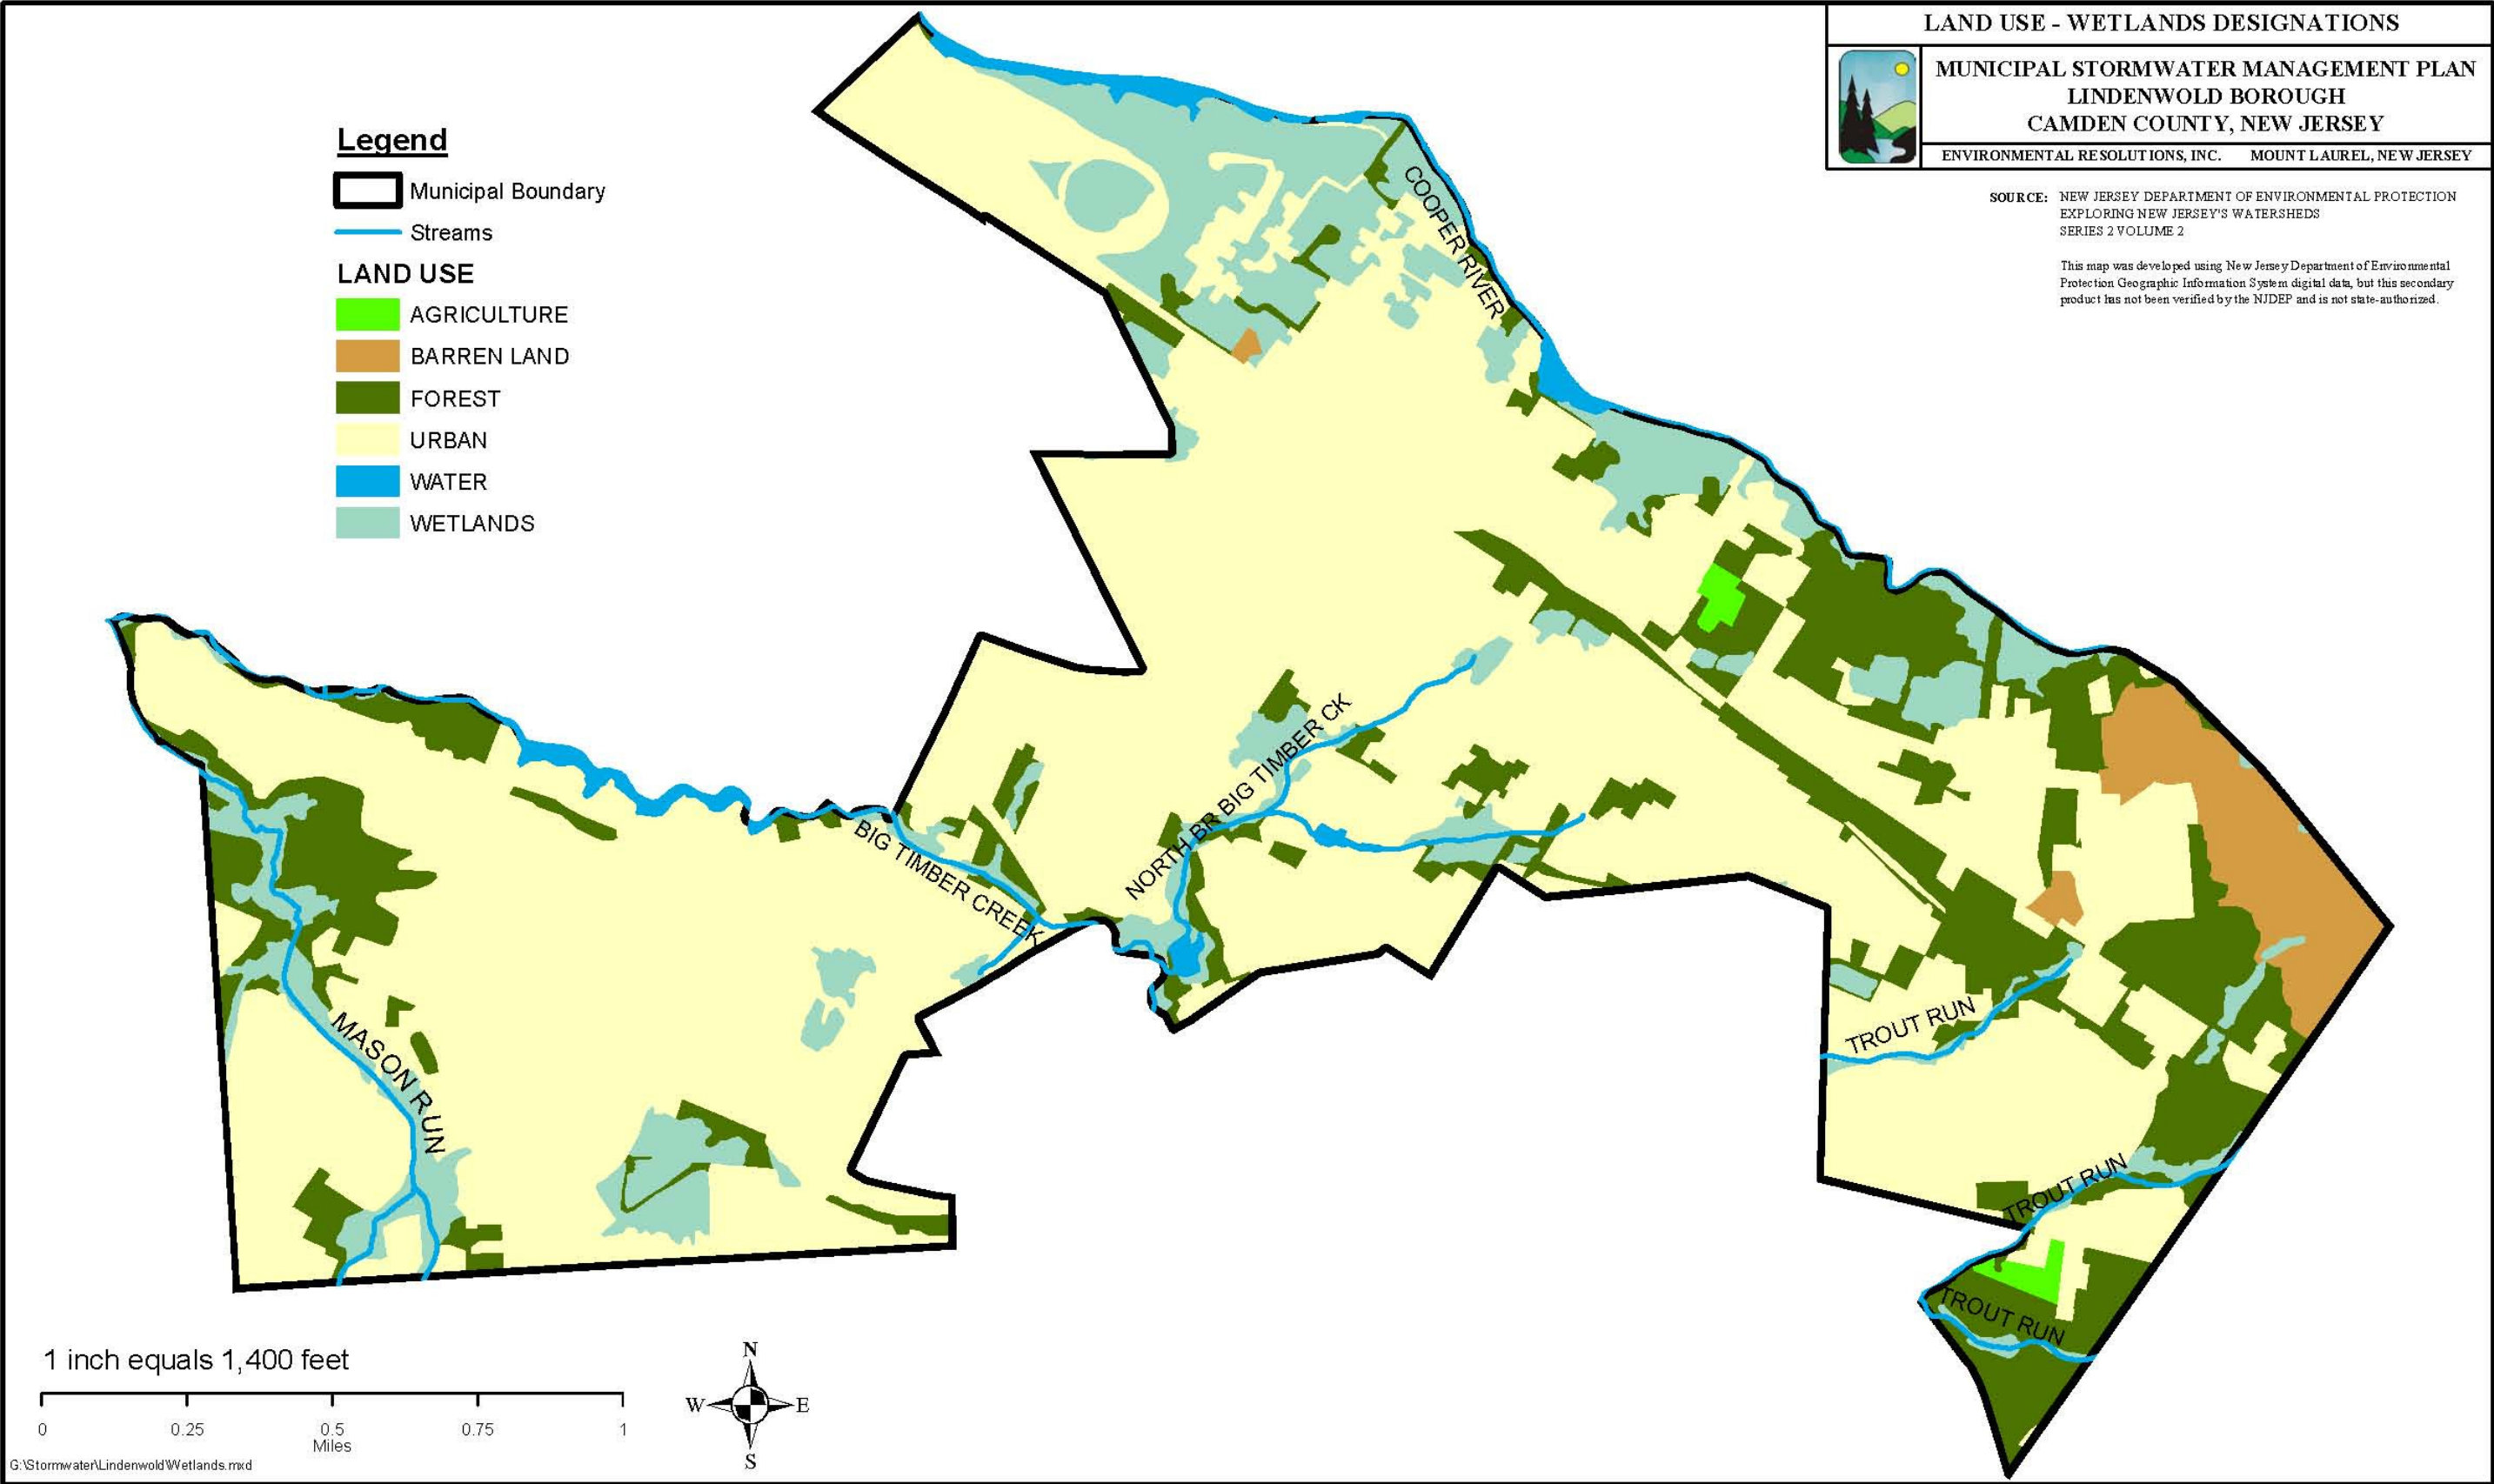
FIGURE 13 – WETLANDS DESIGNATIONS MAP

The wetlands within the Borough of Lindenwold will generally be classified as intermediate resource value under N.J.A.C.7:7A-2.4. The standard width of transition area adjacent to a freshwater wetland of intermediate resource value is fifty (50) feet unless modified through the issuance of a transition area waiver per N.J.A.C.7:7A-6.1(a) through NJDEP. Although the rules for a transition waiver are numerous, it should be noted that without additional municipal ordinances placing more stringent buffers onto environmentally sensitive areas like wetlands, NJDEP may allow the transition area adjacent to a delineated wetland be reduced to ten (10) feet with compensation made elsewhere on the site through issuance of a transition area wavier.

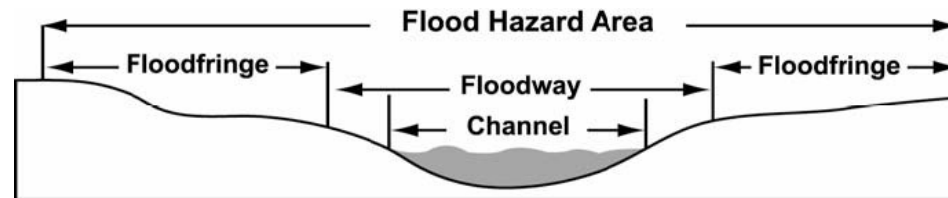
Parts of a Flood Hazard Area

Areas naturally subject to flooding are called floodplains, or flood hazard areas. Floodplains encompass a floodway, which is the portion of a floodplain subject to high velocities of moving water, and the adjacent flood fringe, which helps to hold and carry excess water during overflow of the normal stream channel. The 100-year floodplain is defined as the land area that will be inundated by the overflow of water resulting from a 100-year flood (a flood that has a 1% chance of occurring in any given year).

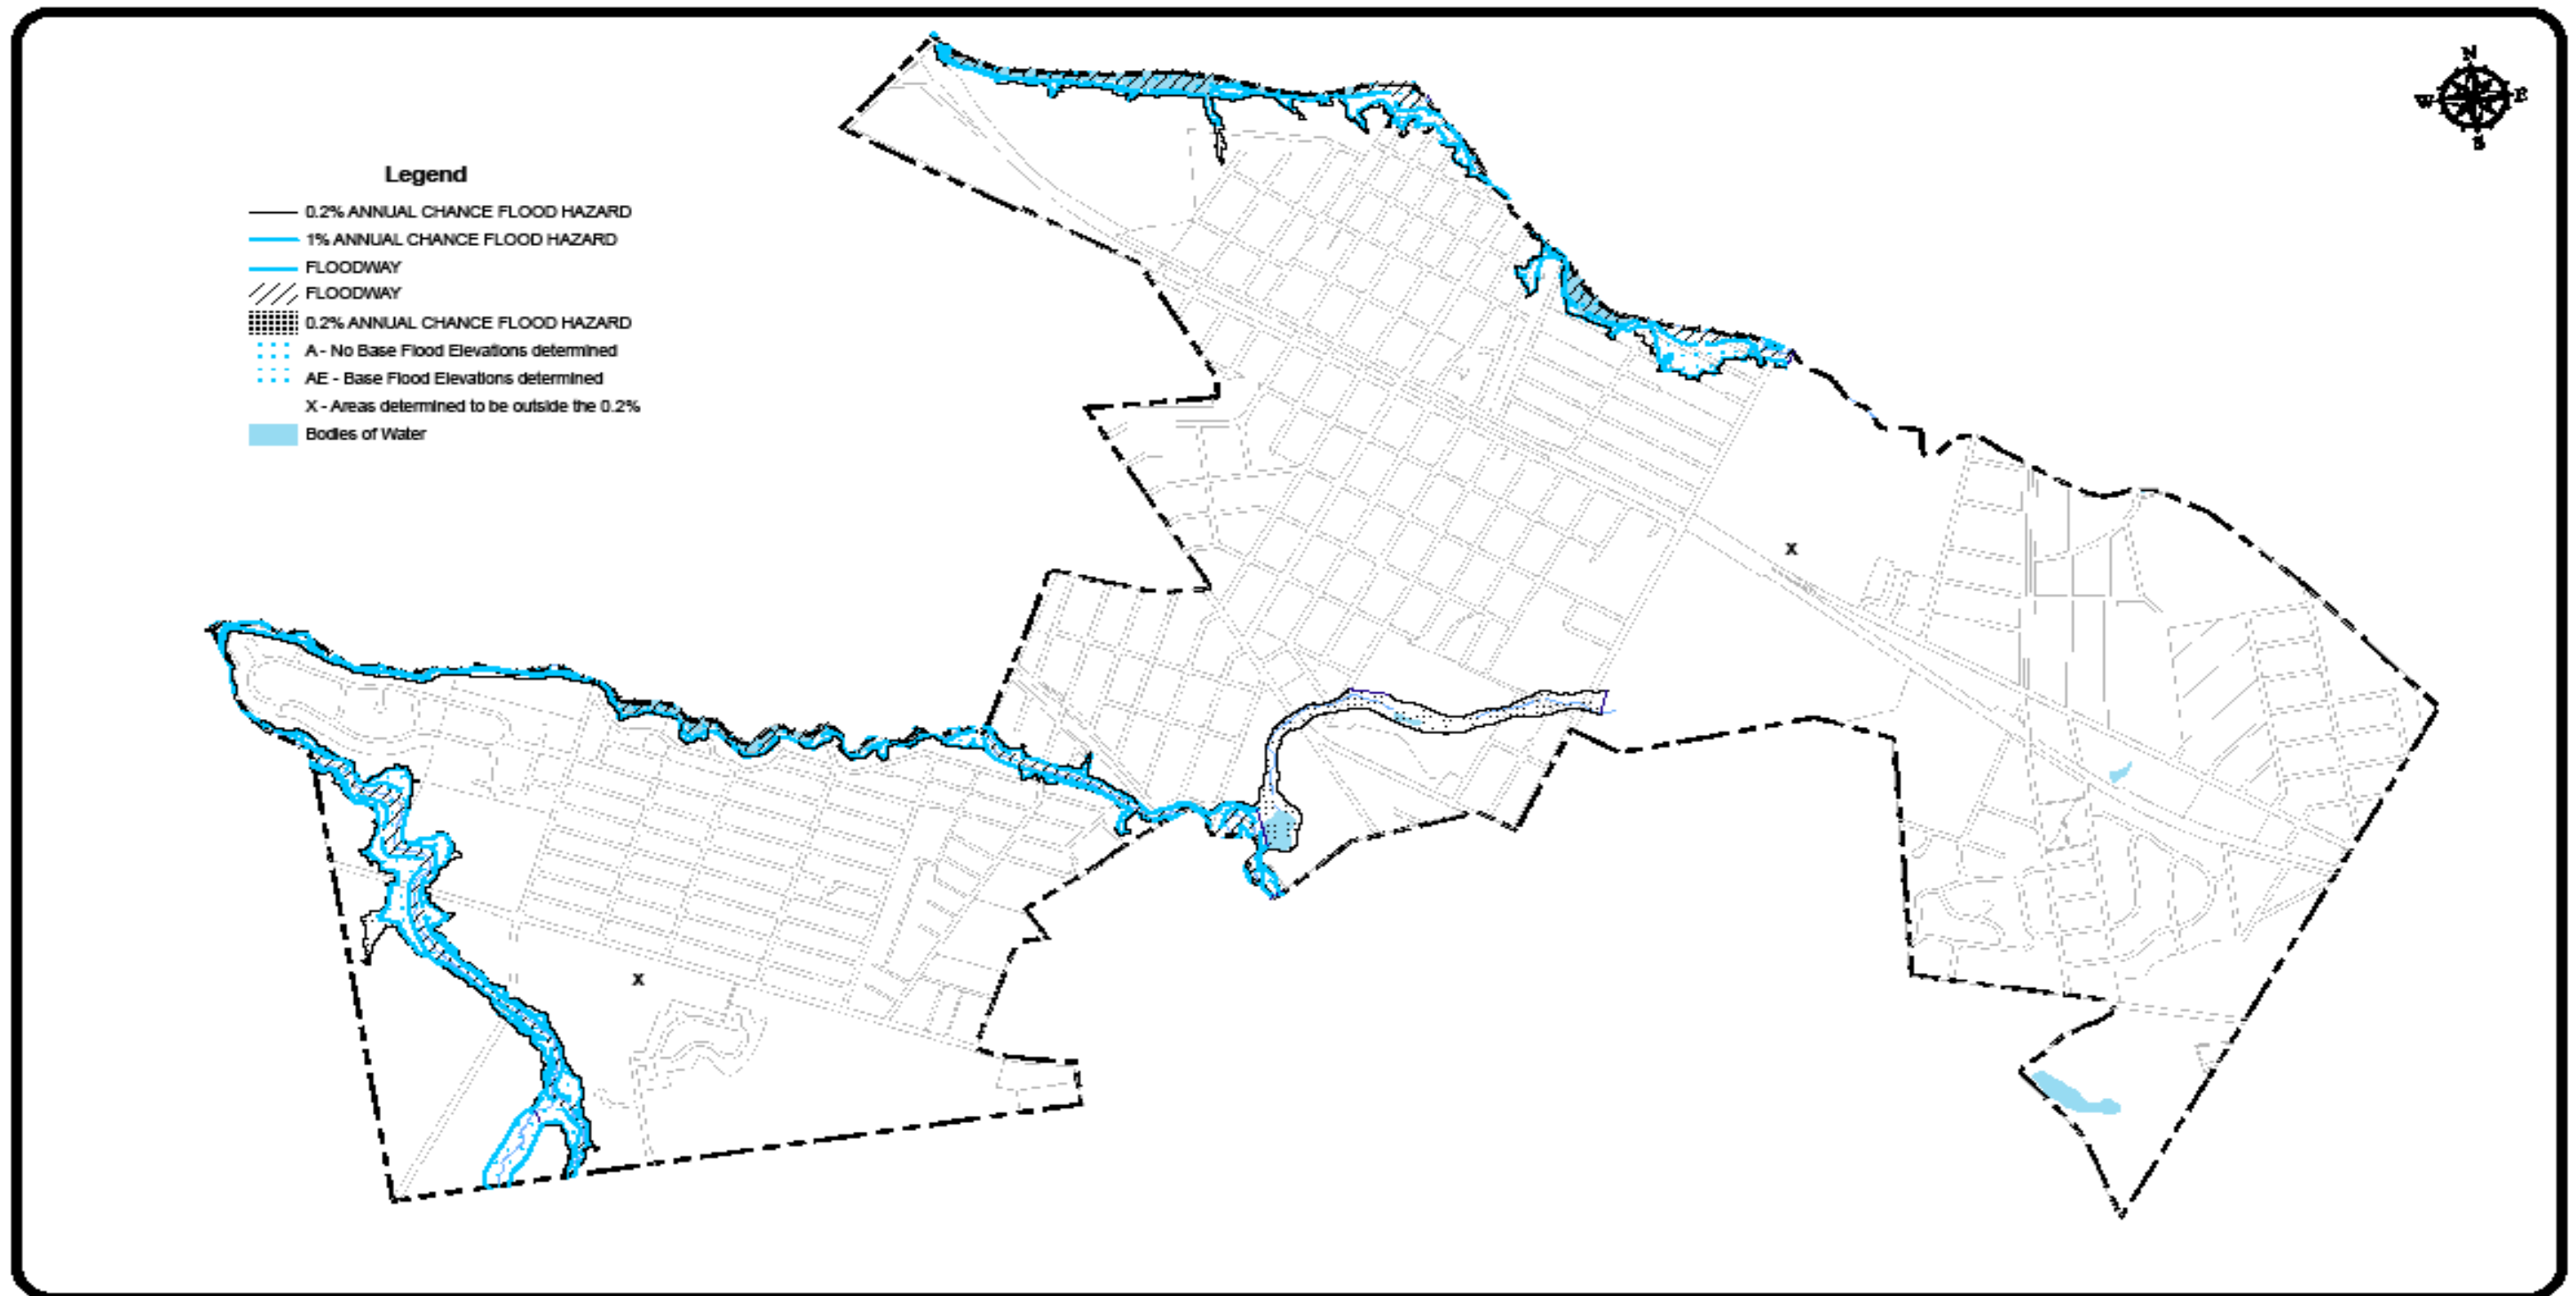
FIGURE 14 – FEMA MAP

AERIALS: FEMA FLOOD INSURANCE RATE DATA EFFECTIVE DATE : 6/16/09
